Fairway Rehabilitation and Maintenance Master Plan

– Danube and its navigable tributaries

EU Strategy for the Danube Region,

Priority Area 1a – To improve mobility and multimodality: inland waterways

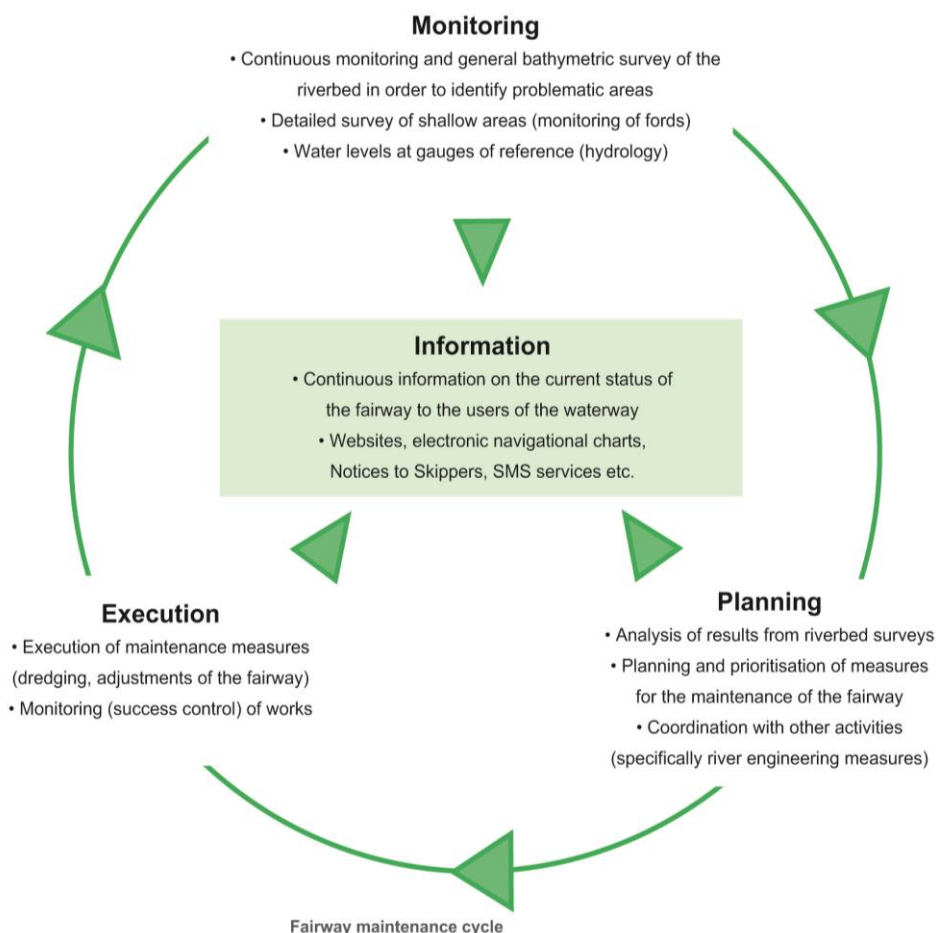
Fig. 1: Fairway maintenance cycle (Source: viadonau)

A river such as the Danube is a living system with continuous changes to the riverbed and its morphology. Locations of critical fairway sections can therefore change from week to week and from year to year. A typical “fairway maintenance cycle” should therefore be first and foremost based on continuous monitoring of the fairway. Each of the process steps in this cycle fulfils specific purposes which are interdependent: The availability of skilled staff, up-to-date sounding and dredging equipment, efficient methods for data collection and tools for targeted information transmission to the users of the waterway are all prerequisites for efficient and effective waterway maintenance on the Danube and its navigable tributaries.

In this Master Plan, the status of maintenance works in the different riparian countries will be presented according to these four phases of the fairway maintenance cycle.

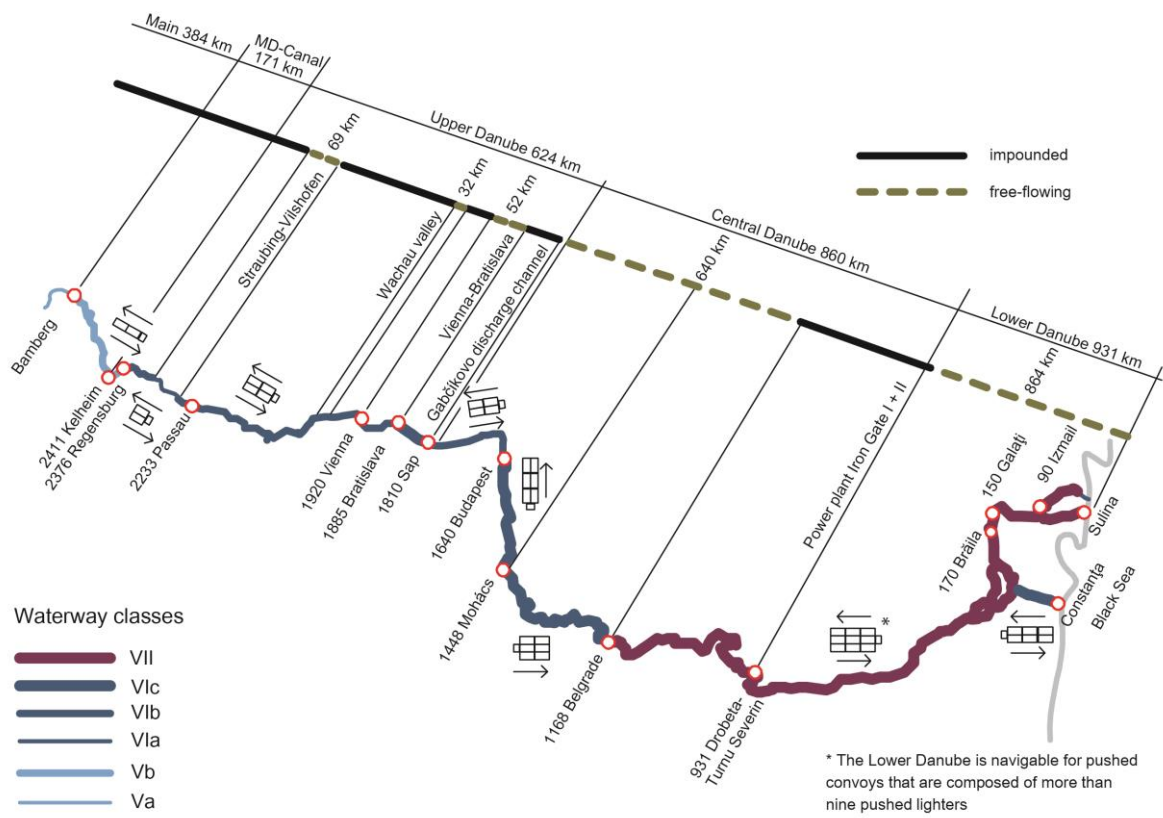
Fig. 3: Maximum possible dimensions of convoys on the Danube waterway according to UNECE waterway classes (Source: viadonau)

The hydrological and hydro-morphological characteristics of the Danube, together with river engineering interventions, determine the nautical situation on the waterway. Figure 3 depicts the maximum possible dimensions of vessels and convoys on the Danube waterway from Kelheim in Germany to the Black Sea related to waterway classes as defined by the UNECE.

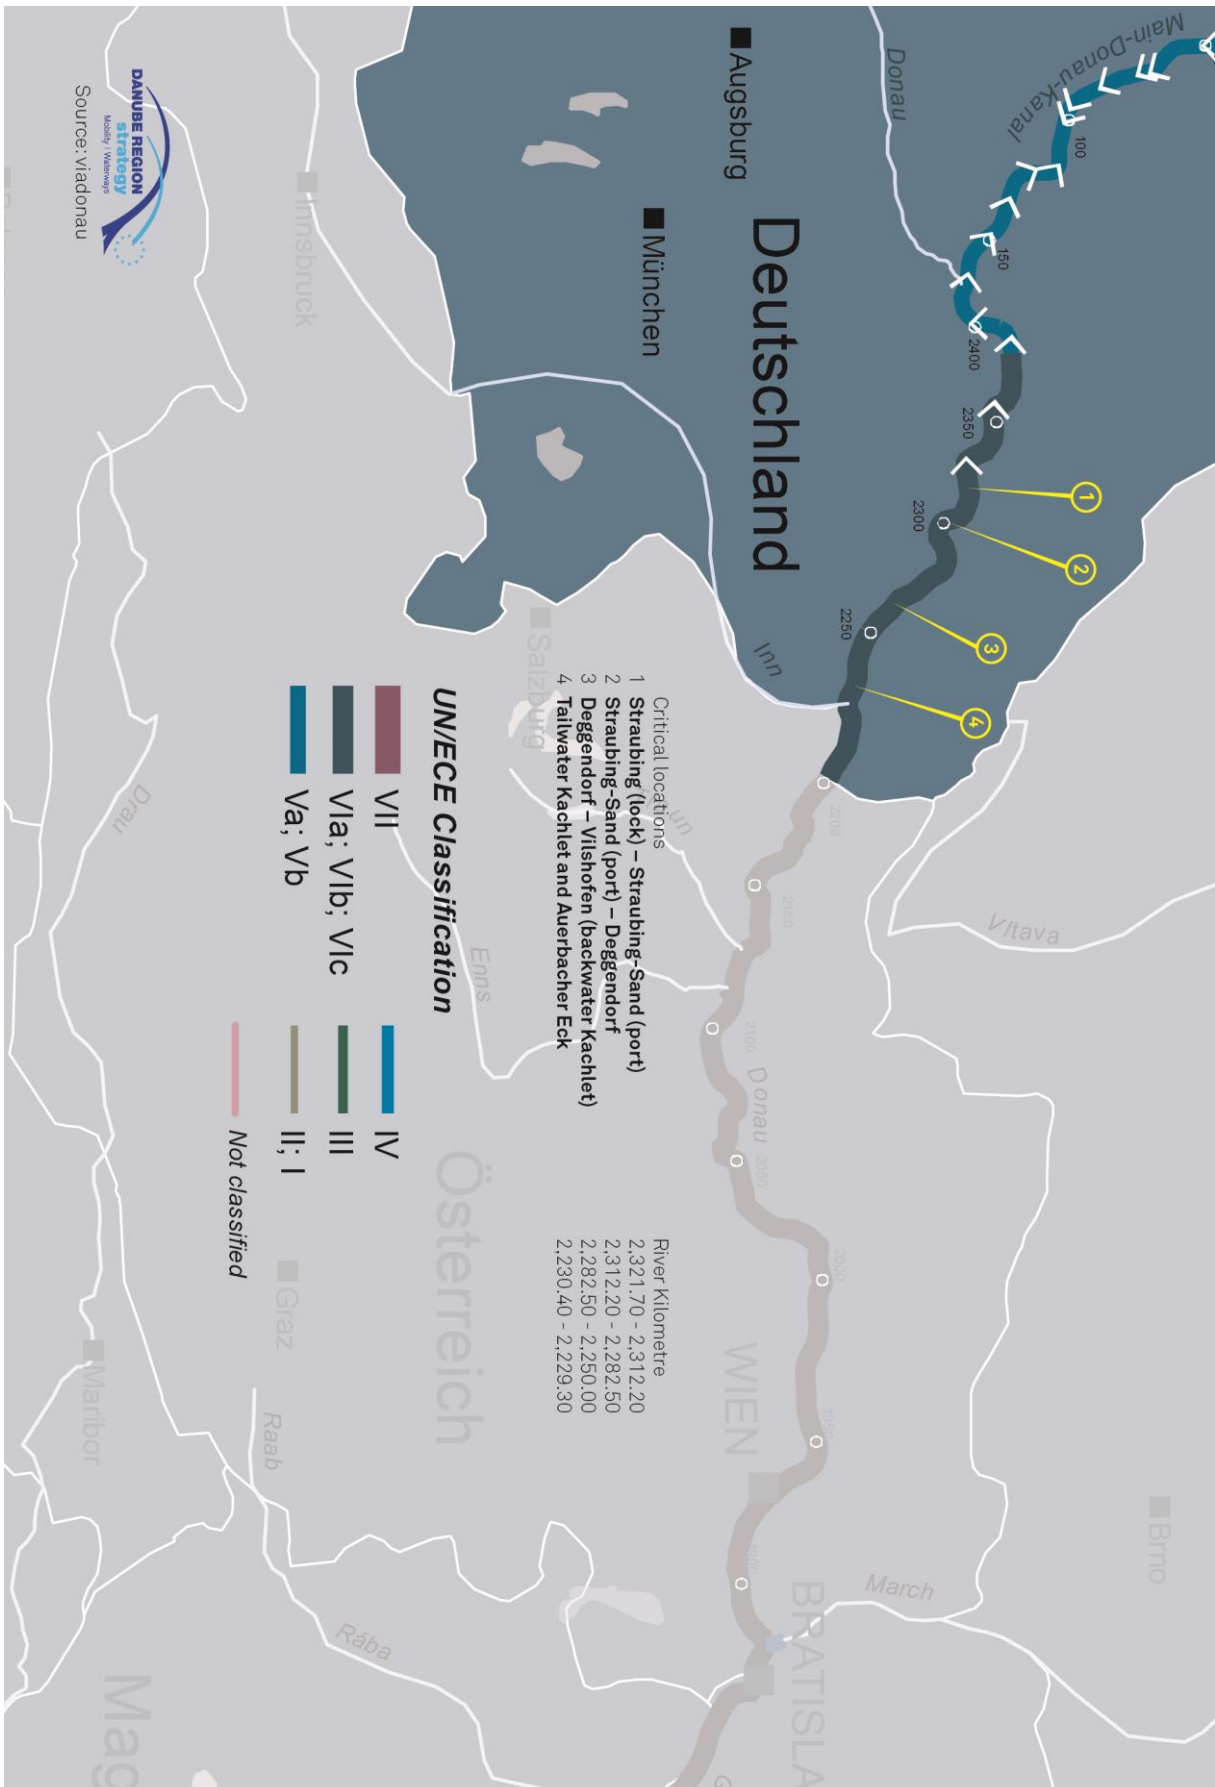
Germany: Overview of Critical Locations

Location / Length (km)			right bank / left bank	Name of sector / location
River-km (from / to)	Length			
2,321.7	2,312.2	9.5	DE / DE	Straubing (lock)–Straubing-Sand (port)
2,312.2	2,282.5	29.7	DE / DE	Straubing-Sand (port)–Deggendorf
2,282.5	2,250.0	32.5	DE / DE	Deggendorf – Vilshofen (backwater Kachlet)
2,230.4	2,229.3	1.1	DE / DE	Tailwater Kachlet and Auerbacher Eck

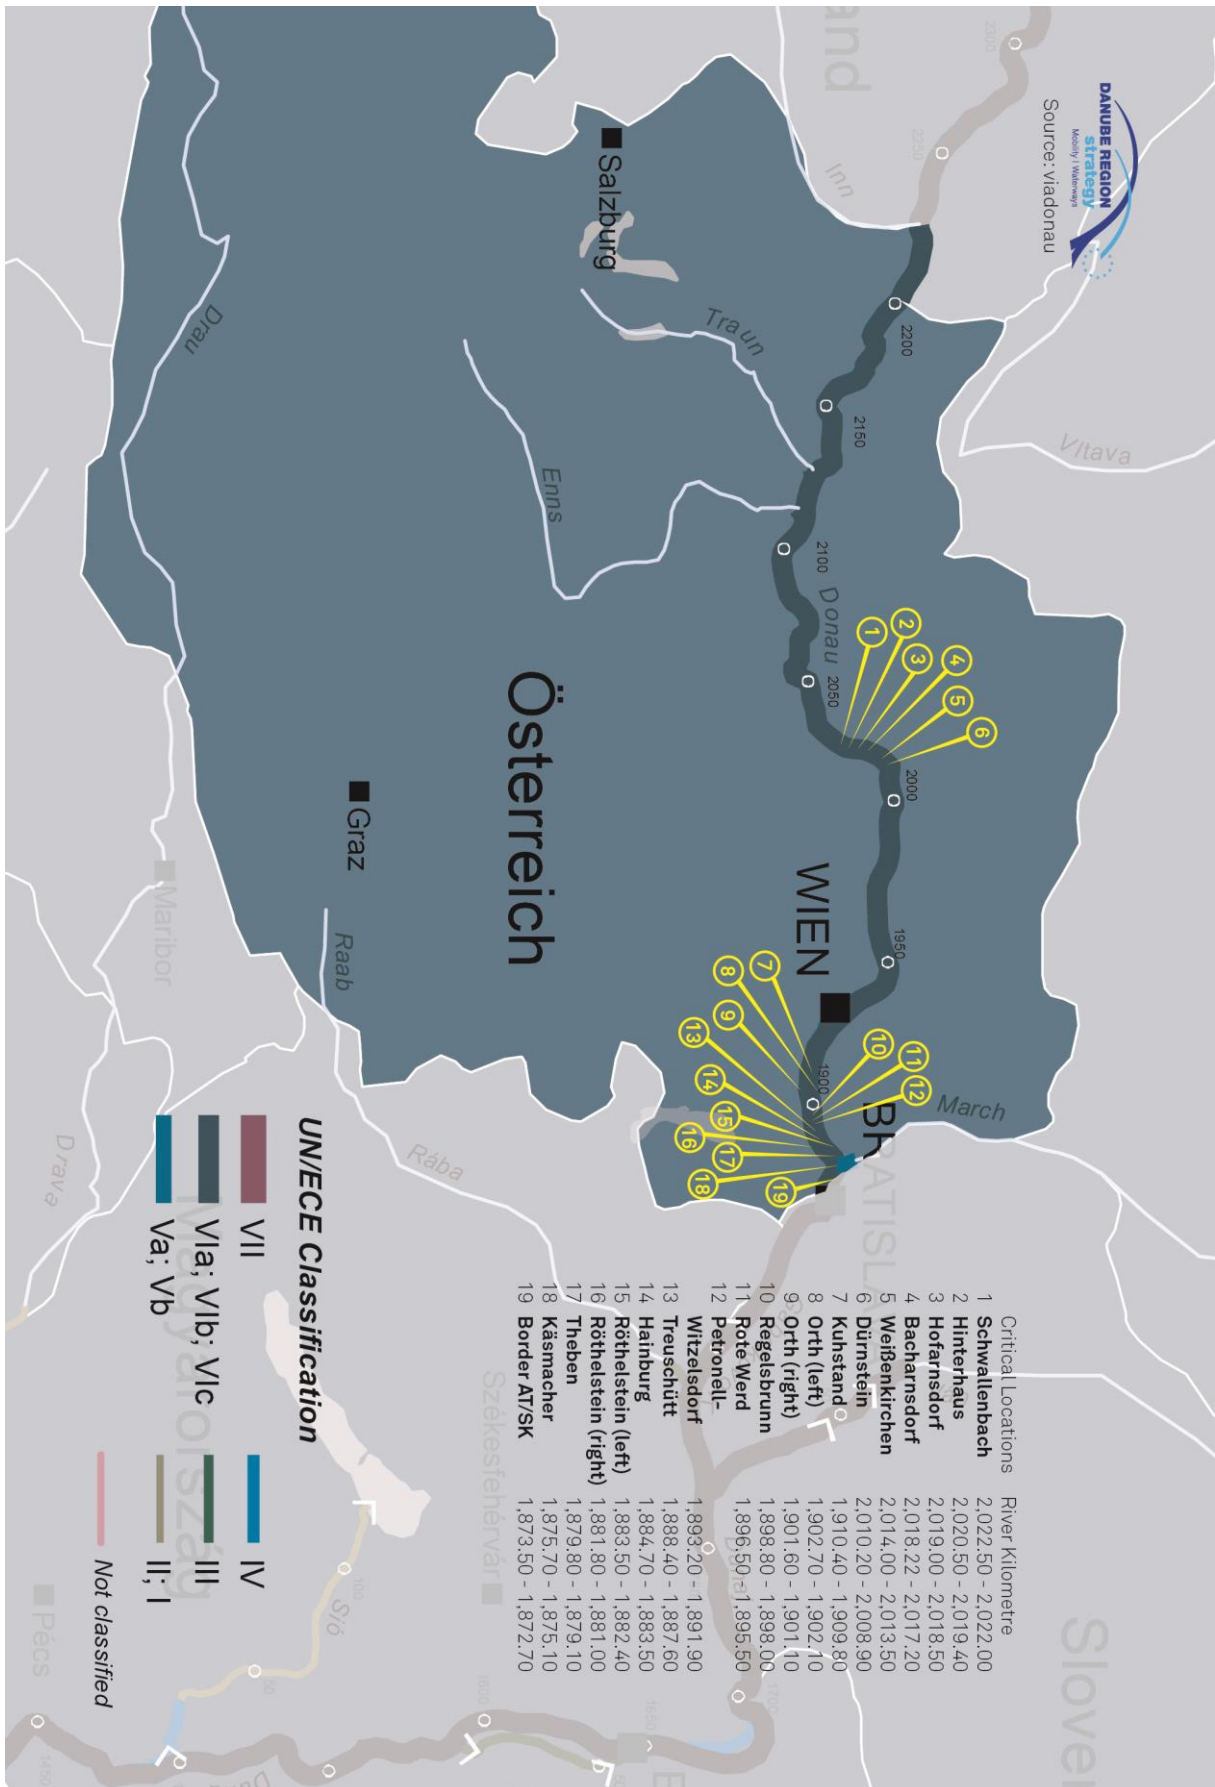
Austria: Overview of Critical Locations

Location / Length (km)			Right bank/ Left bank	Name of sector / location
River-km (from / to)		Length		
2,022.50	2,022.00	0.50	AT / AT	Schwallenbach
2,020.50	2,019.40	1.10	AT / AT	Hinterhaus
2,019.00	2,018.50	0.50	AT / AT	Hofarnsdorf (Spitz)
2,018.20	2,017.20	1.00	AT / AT	Bacharnsdorf
2,014.00	2,013.50	0.50	AT / AT	Weißkirchen
2,010.20	2,008.90	1.30	AT / AT	Dürnstein
1,910.40	1,909.80	0.60	AT / AT	Kuhstand
1,902.70	1,902.10	0.60	AT / AT	Orth (left bank)
1,901.60	1,901.10	0.50	AT / AT	Orth (right bank)
1,898.80	1,898.00	0.80	AT / AT	Regelsbrunn
1,896.50	1,895.50	1.00	AT / AT	Rote Werd
1,893.20	1,891.90	1.30	AT / AT	Petronell-Witzelsdorf
1,888.40	1,887.60	0.80	AT / AT	Treuschütt
1,884.70	1,883.50	1.20	AT / AT	Hainburg
1,883.50	1,882.40	1.10	AT / AT	Röthelstein (left bank)
1,881.80	1,881.00	0.80	AT / AT	Röthelstein (right bank)
1,879.80	1,879.10	0.70	AT / SK	Theben
1,875.70	1,875.10	0.60	AT / SK	Käsmacher
1,873.50	1,872.70	0.80	AT / SK	Border AT / SK

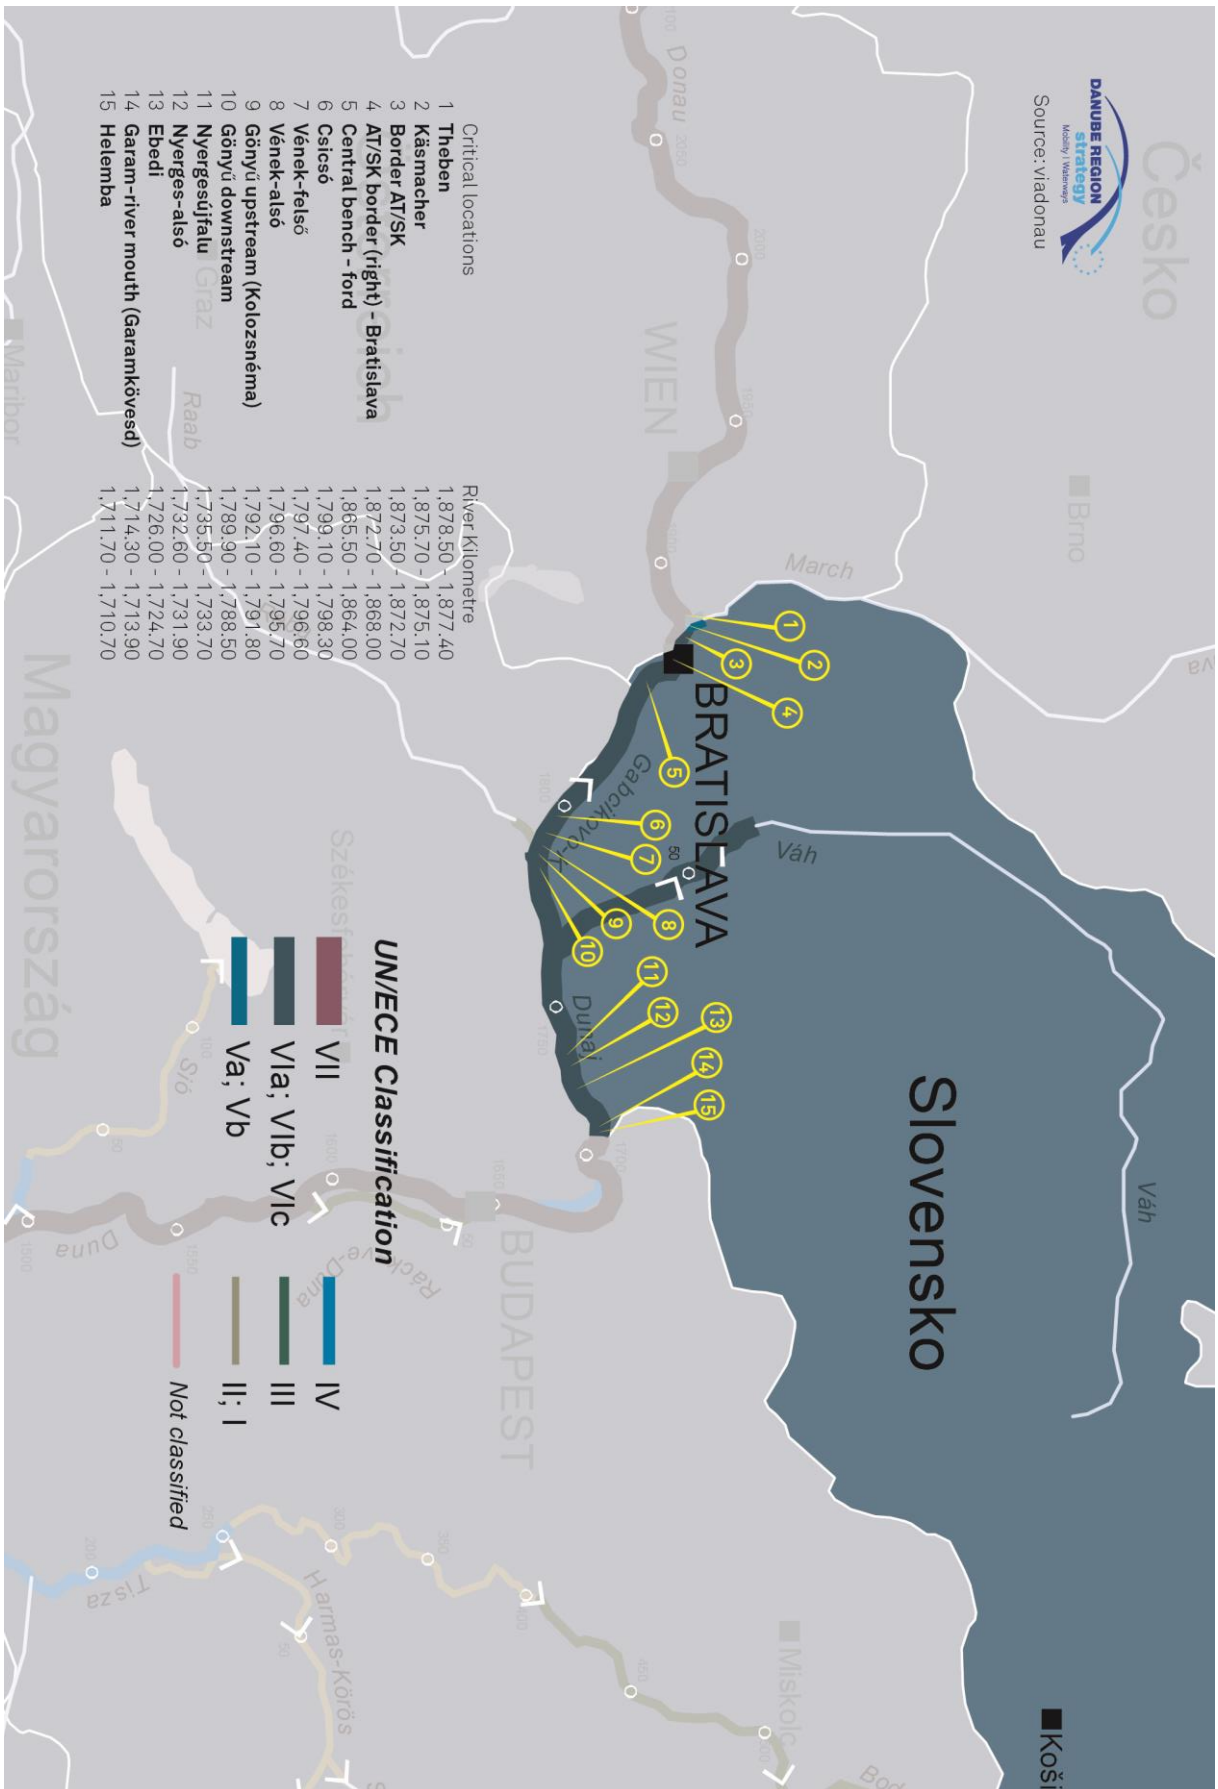
Slovakia: Overview of Critical Locations

Location / Length (km)			right bank / left bank	Name of sector / location
River-km (from / to)	Length			
1,878.50	1,877.40	1.10	AT / SK	Theben
1,875.70	1,875.10	0.60	AT / SK	Käsmacher
1,873.50	1,872.70	0.80	AT / SK	Border AT / SK
1,872.70	1,868.00	0.20	SK / SK	AT/SK border (right bank) - Bratislava
1,865.50	1,864.00	1.50	SK / SK	Central bench - ford
1,799.10	1,798.30	0.80	HU / SK	Csicsó
1,797.40	1,796.60	0.80	HU / SK	Vének-felső
1,796.60	1,795.70	0.90	HU / SK	Vének-alsó
1,792.10	1,791.80	0.30	HU / SK	Gönyű upstream (Kolozs néma)
1,789.90	1,788.50	1.40	HU / SK	Gönyű downstream
1,735.50	1,733.70	1.80	HU / SK	Nyergesújfalu
1,732.60	1,731.90	0.70	HU / SK	Nyerges-alsó
1,726.00	1,724.70	1.30	HU / SK	Ebedi
1,714.30	1,713.90	0.40	HU / SK	Garam-river mouth (Garamkövesd)
1,711.70	1,710.70	1.00	HU / SK	Helemba

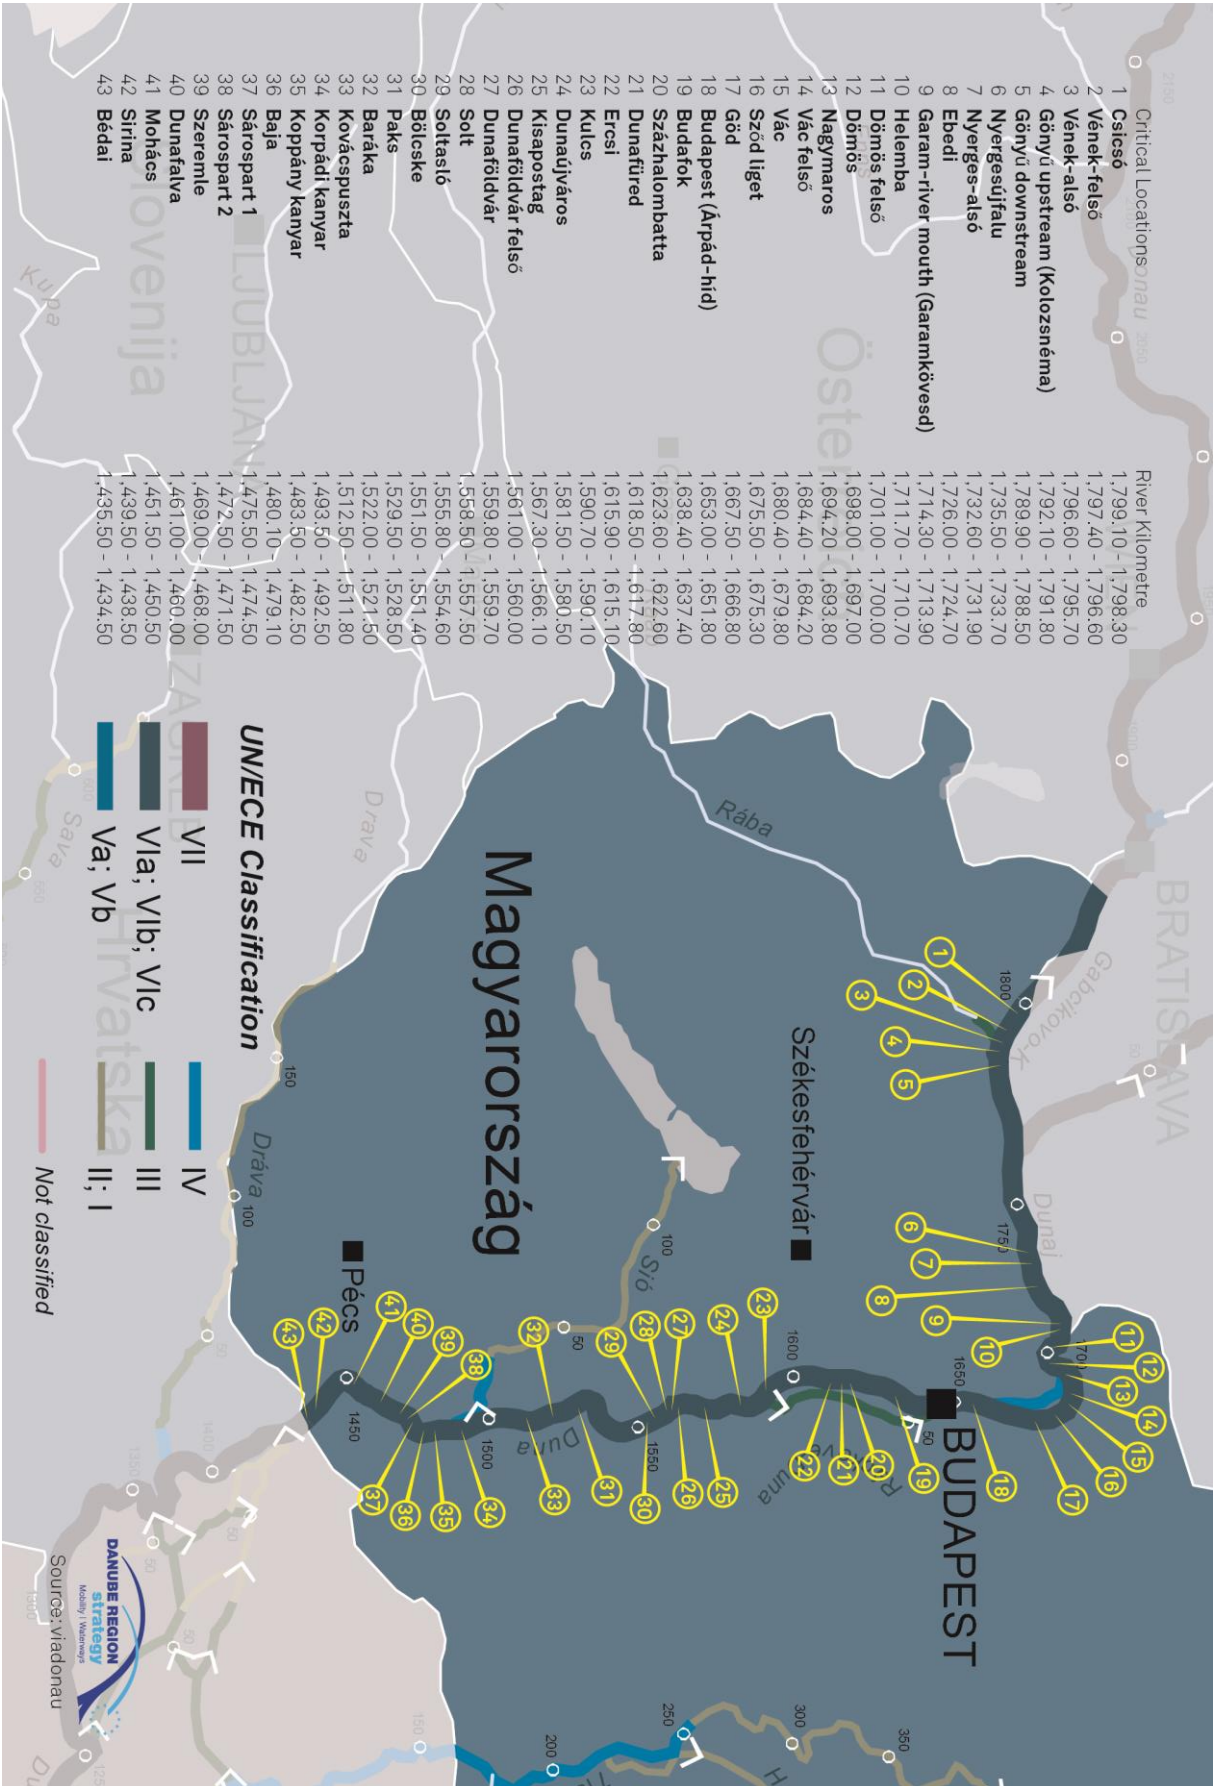
Hungary: Overview of Critical Locations

1,561.00	1,560.00	1.00	HU / HU	Dunaföldvár felső
1,559.80	1,559.70	0.10	HU / HU	Dunaföldvár
1,558.50	1,557.50	1.00	HU / HU	Solt
1,555.80	1,554.60	1.20	HU / HU	Soltasló
1,551.50	1,551.40	0.10	HU / HU	Bölcske
1,529.50	1,528.50	1.00	HU / HU	Paks
1,522.00	1,521.50	0.50	HU / HU	Baráka
1,512.50	1,511.80	0.70	HU / HU	Kovácspuszta
1,493.50	1,492.50	1.00	HU / HU	Korpádi kanyar
1,483.50	1,482.50	1.00	HU / HU	Koppány kanyar
1,480.10	1,479.10	1.00	HU / HU	Baja
1,475.50	1,474.50	1.00	HU / HU	Sárospart 1
1,472.50	1,471.50	1.00	HU / HU	Sárospart 2
1,469.00	1,468.00	1.00	HU / HU	Szeremle
1,461.00	1,460.00	1.00	HU / HU	Dunafalva
1,451.50	1,450.50	1.00	HU / HU	Mohács
1,439.50	1,438.50	1.00	HU / HU	Sirina
1,435.50	1,434.50	1.00	HU / HU	Bédai

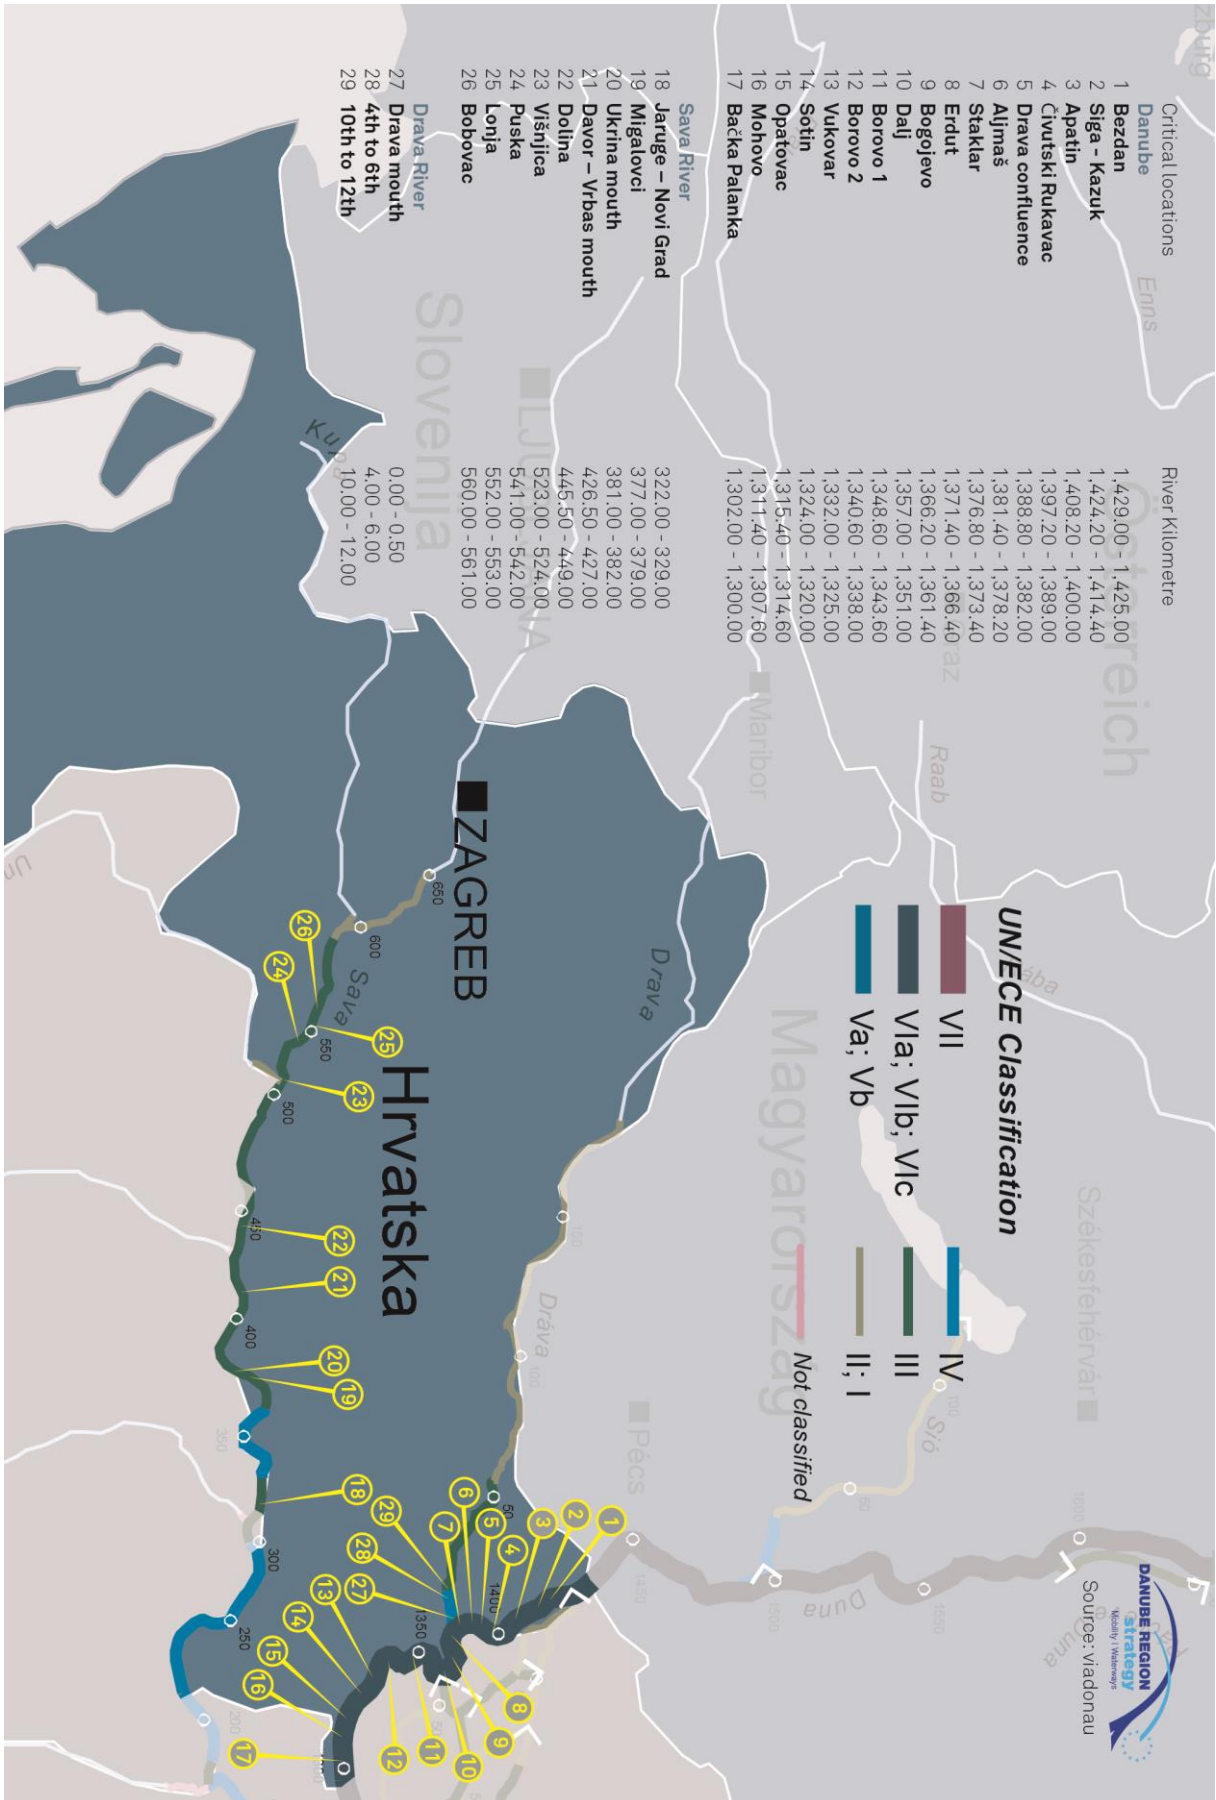
Croatia: Overview of Critical Locations

Location / Length (km)			right bank / left bank	Name of sector / location
River-km (from / to)		Length		
0.00	0.50	0.50	HR / HR	Drava mouth
4.00	6.00	2.00	HR / HR	4 th to 6 th
10.00	12.00	2.00	HR / HR	10 th to 12 th

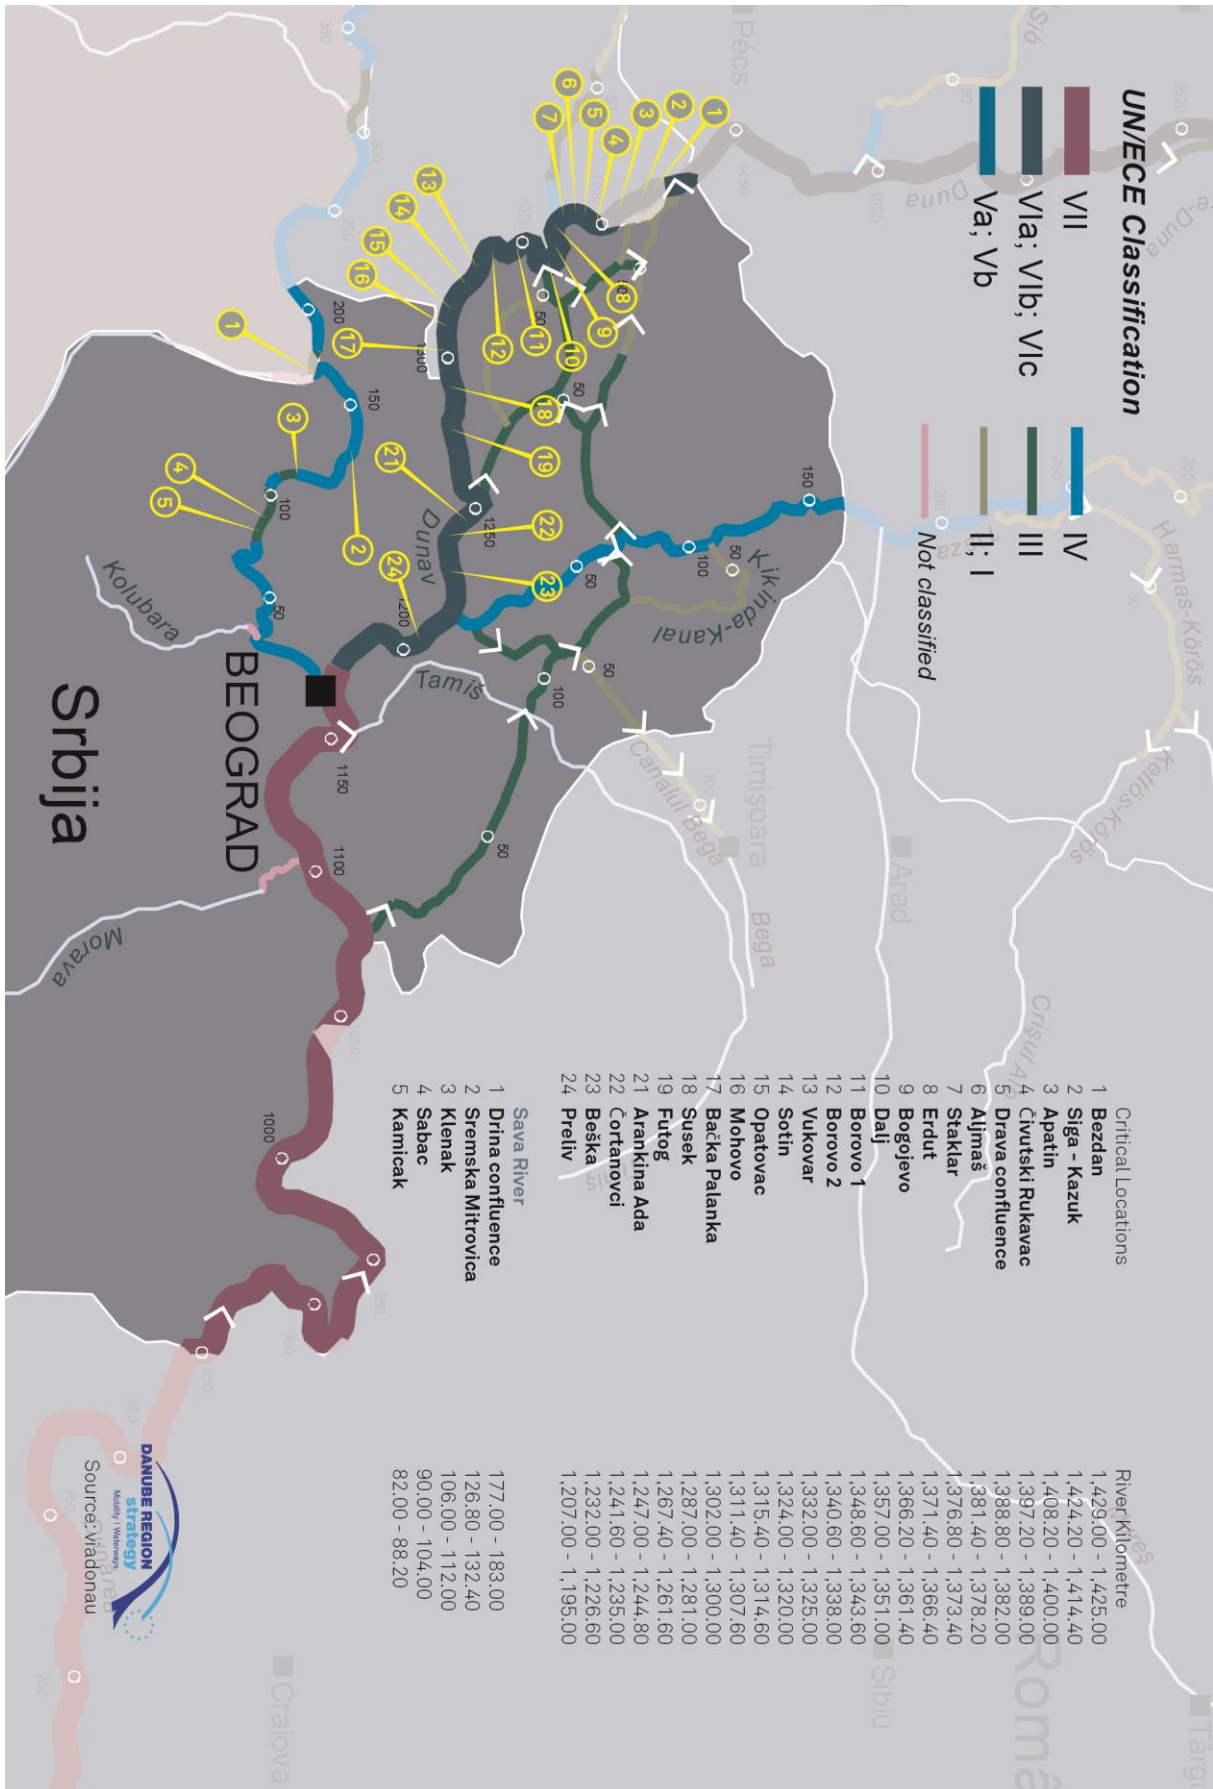
Serbia: Overview of Critical Locations

Location / Length (km)			right bank / left bank	Name of sector / location
River-km (from / to)		Length		
82.00	88.20	6,20	RS	Kamicak
90.00	104.00	14,00	RS	Sabac
106.00	112.00	6,00	RS	Klenak
126.80	132.40	6,40	RS	Sremska Mitrovica
177.00	183.00	6,00	RS / BA	Drina confluence

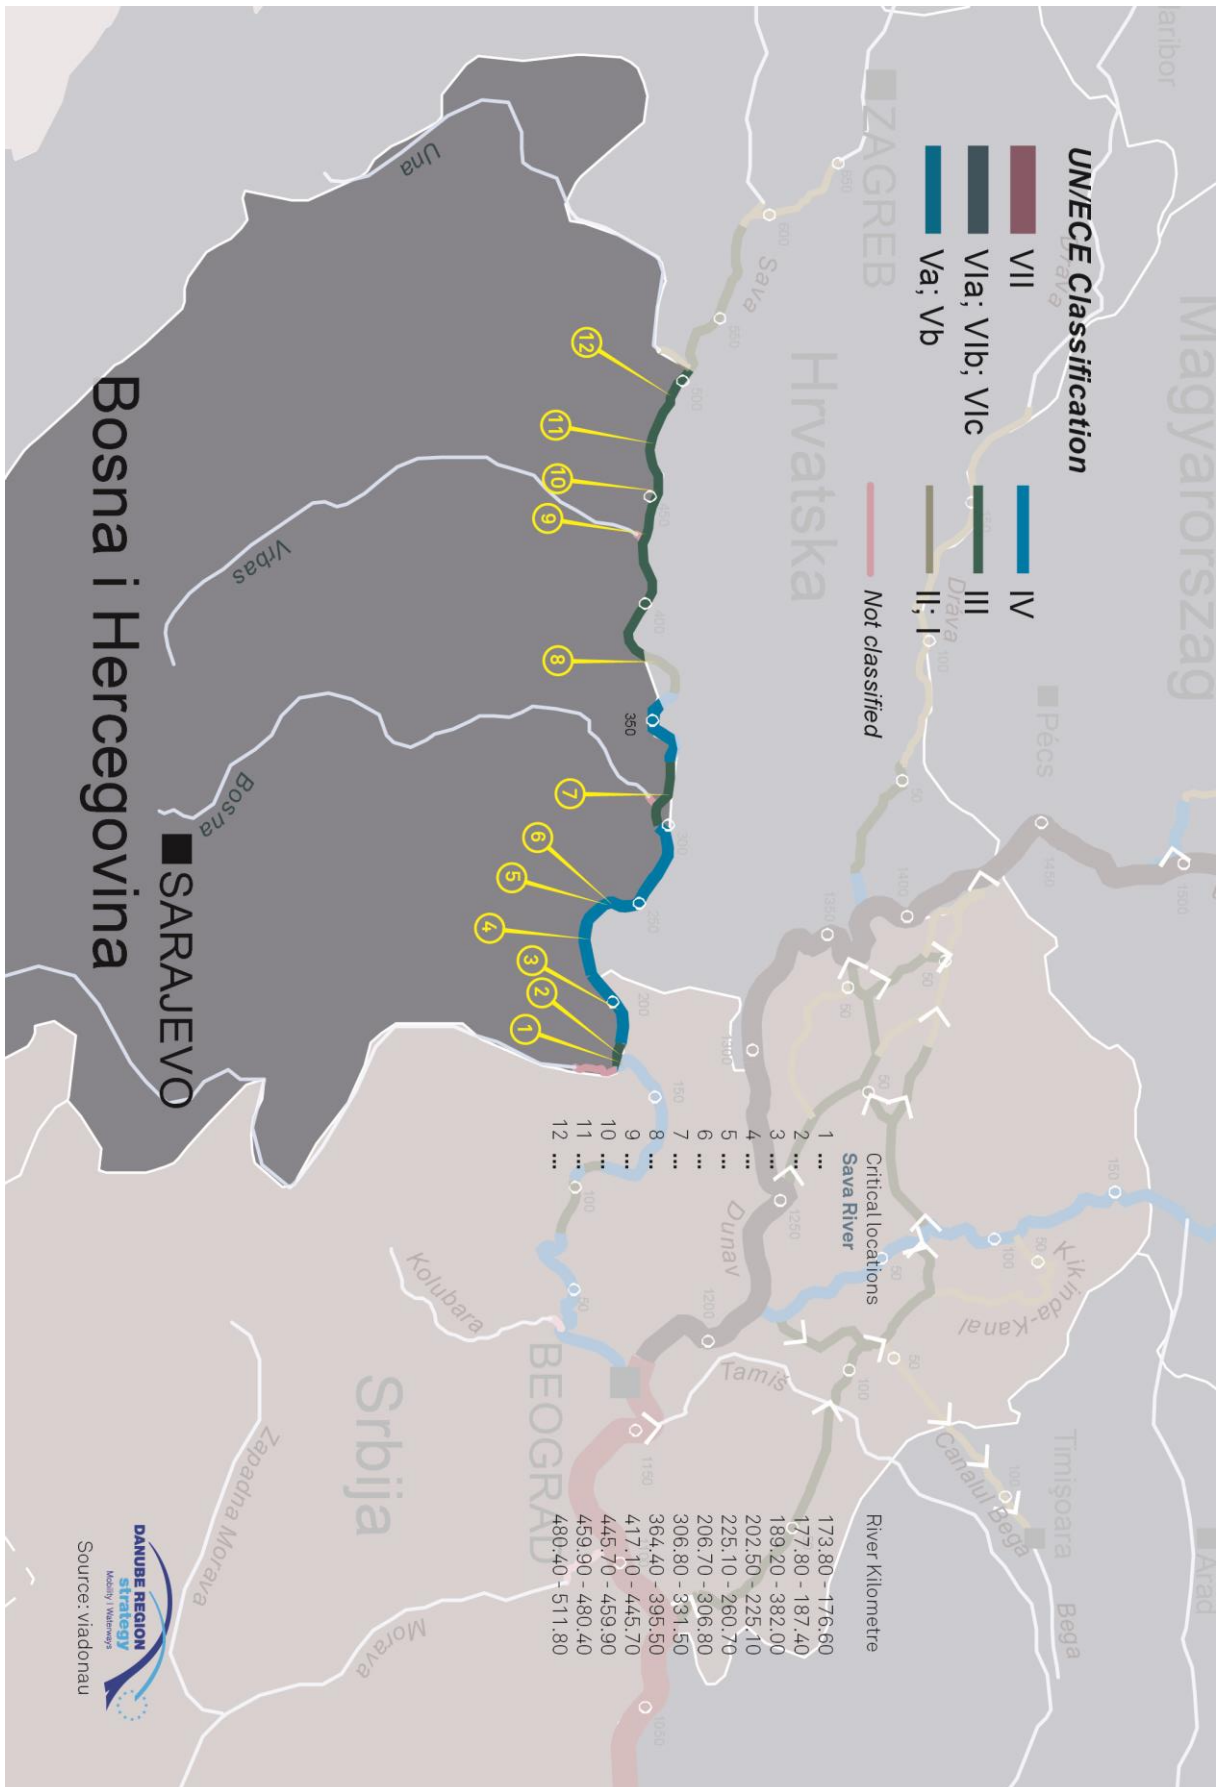
Bosnia and Herzegovina: Overview of Critical Locations

Location / Length (km)			Right bank/ Left bank	Name of sector / location
River-km (from / to)		Length		
69,7	72,9	3,2		
79,9	85,8	5,9		
88,3	101,9	13,6		
103,5	109,8	6,3		
173,8	176,6	2,8		
177,8	187,4	9,6		
189,2	202,5	13,3		
202,5	225,1	22,6		
225,1	260,7	35,6		
206,7	306,8	100,1		
306,8	331,5	24,7		
364,4	395,5	31,1		
417,1	445,7	28,6		
445,7	459,9	14,2		
459,9	480,4	20,5		
480,4	511,8	31,4

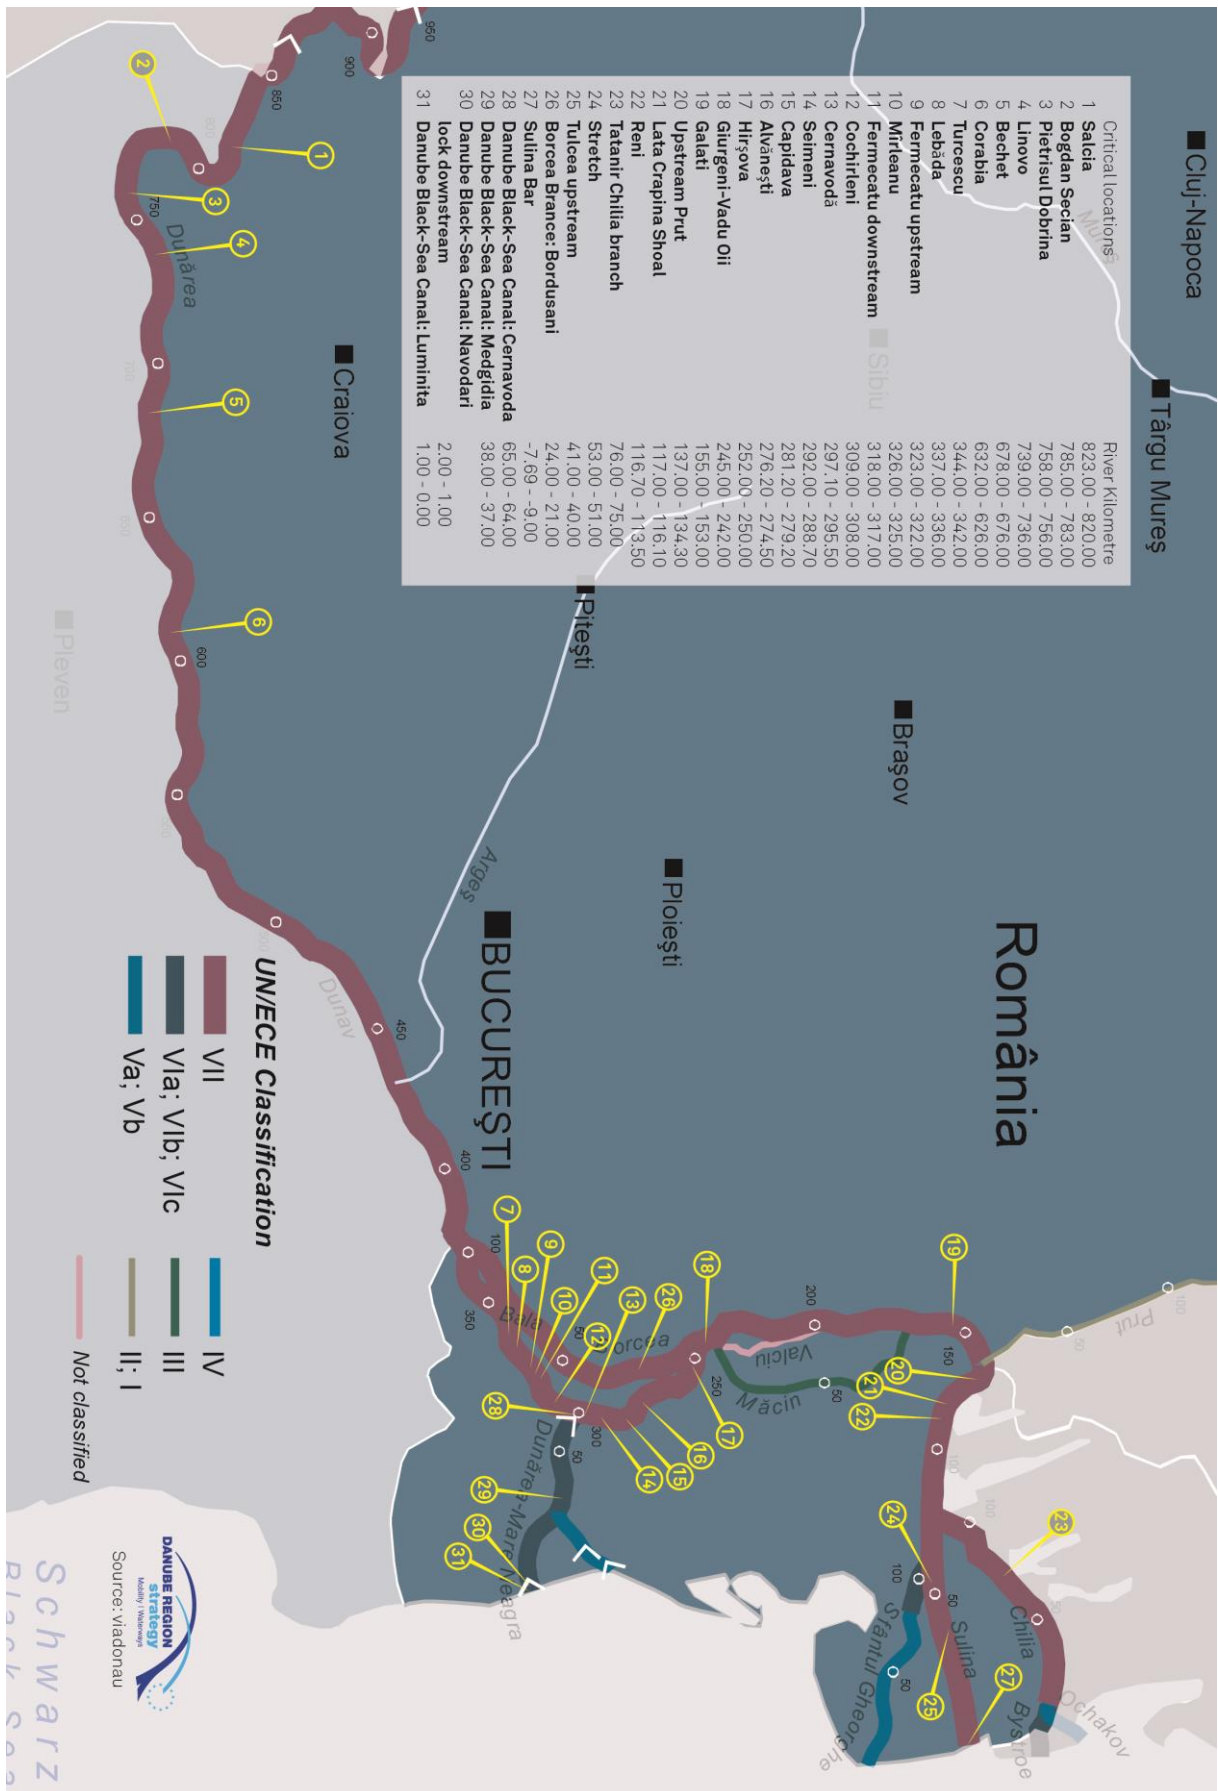
Romania: Overview of Critical Locations

38.00	37.00	1.00	RO / RO	Danube Black-Sea Canal: Medgidia
2.00	1.00	1.00	RO / RO	Danube Black-Sea Canal: Navodari lock downstream
1.00	0.00	1.00	RO / RO	Danube Black-Sea Canal: Luminita

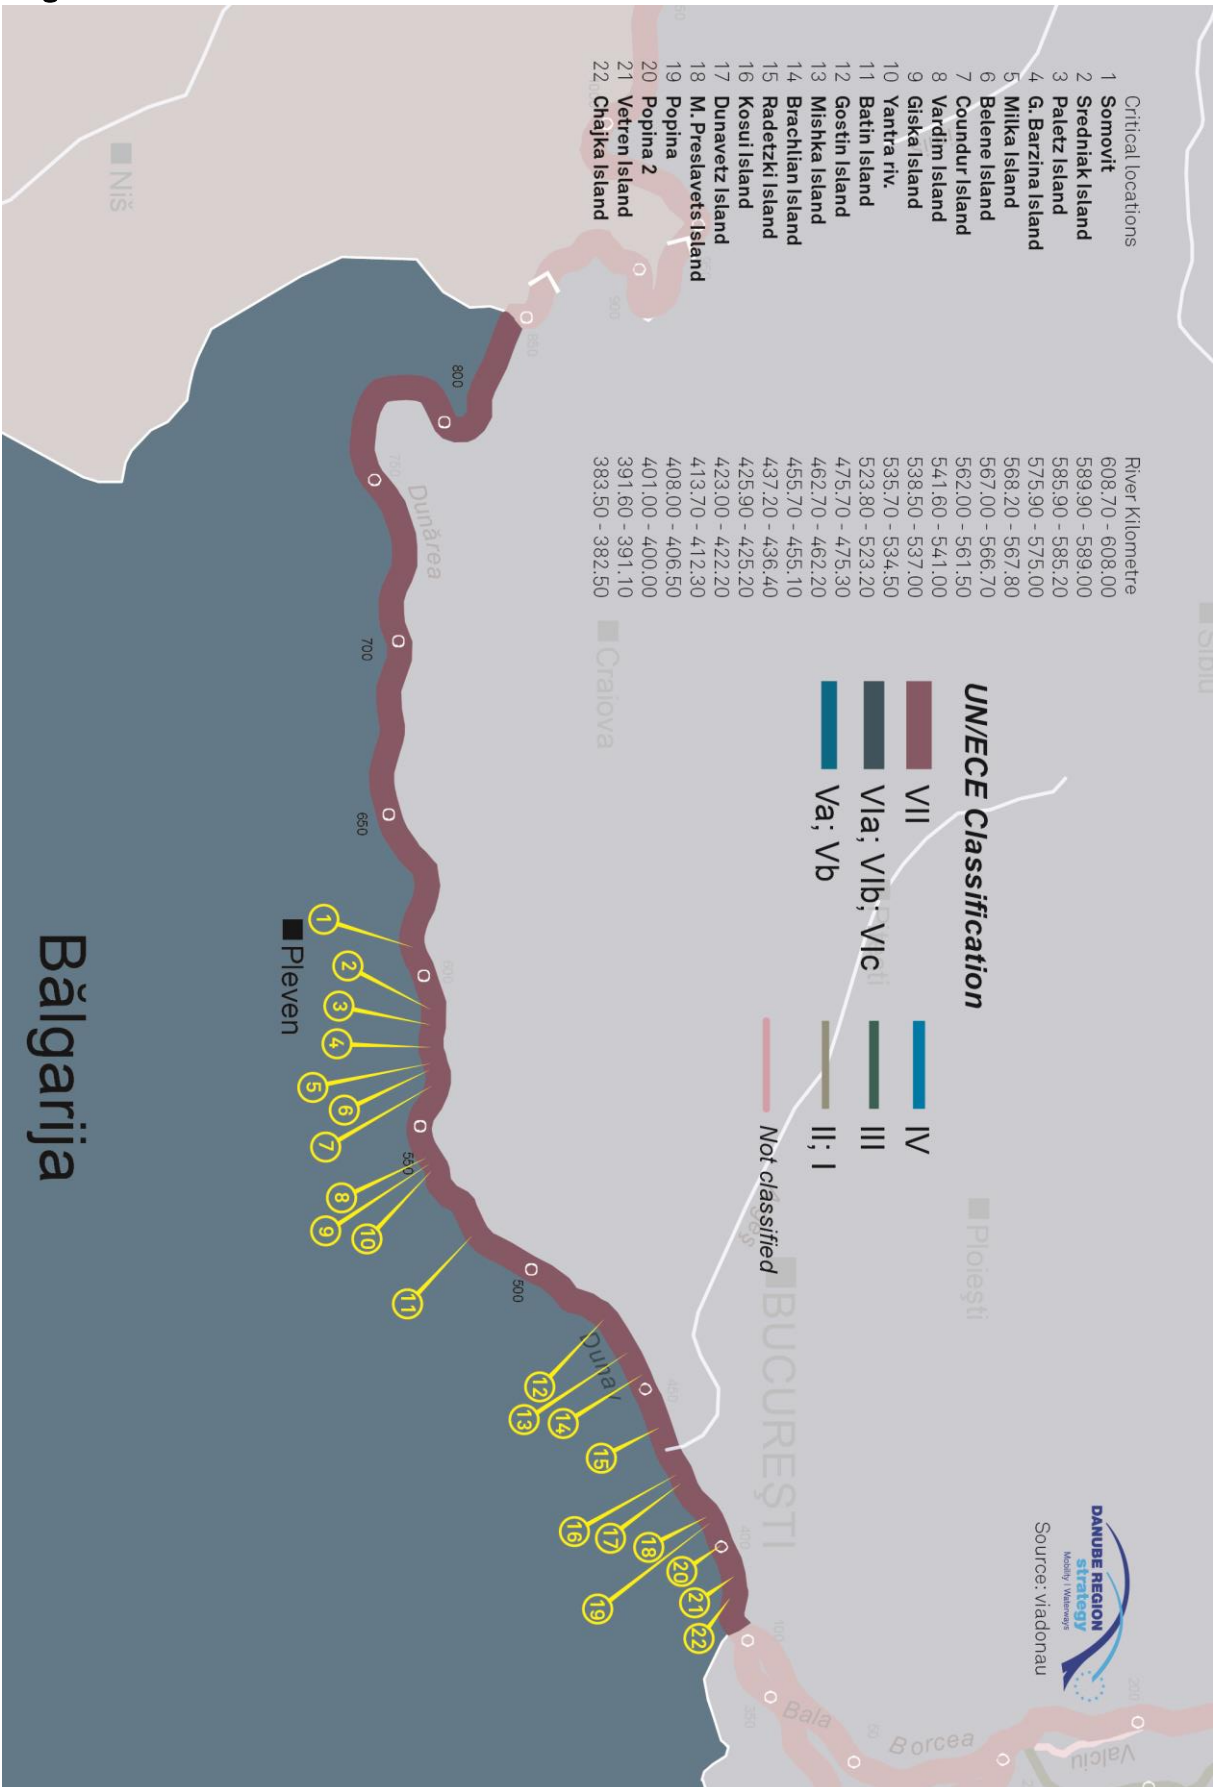
Bulgaria: Overview of Critical Locations

408.00	406.50	1.50	BG / RO	Popina
401.00	400.00	1.00	BG / RO	Popina 2
391.60	391.10	0.50	BG / RO	Vetren Island
383.50	382.50	1.00	BG / RO	Chajka Island
