Fairway Rehabilitation and Maintenance Master Plan

– Danube and its navigable tributaries

EU Strategy for the Danube Region,

Priority Area 1a – To improve mobility and multimodality: inland waterways

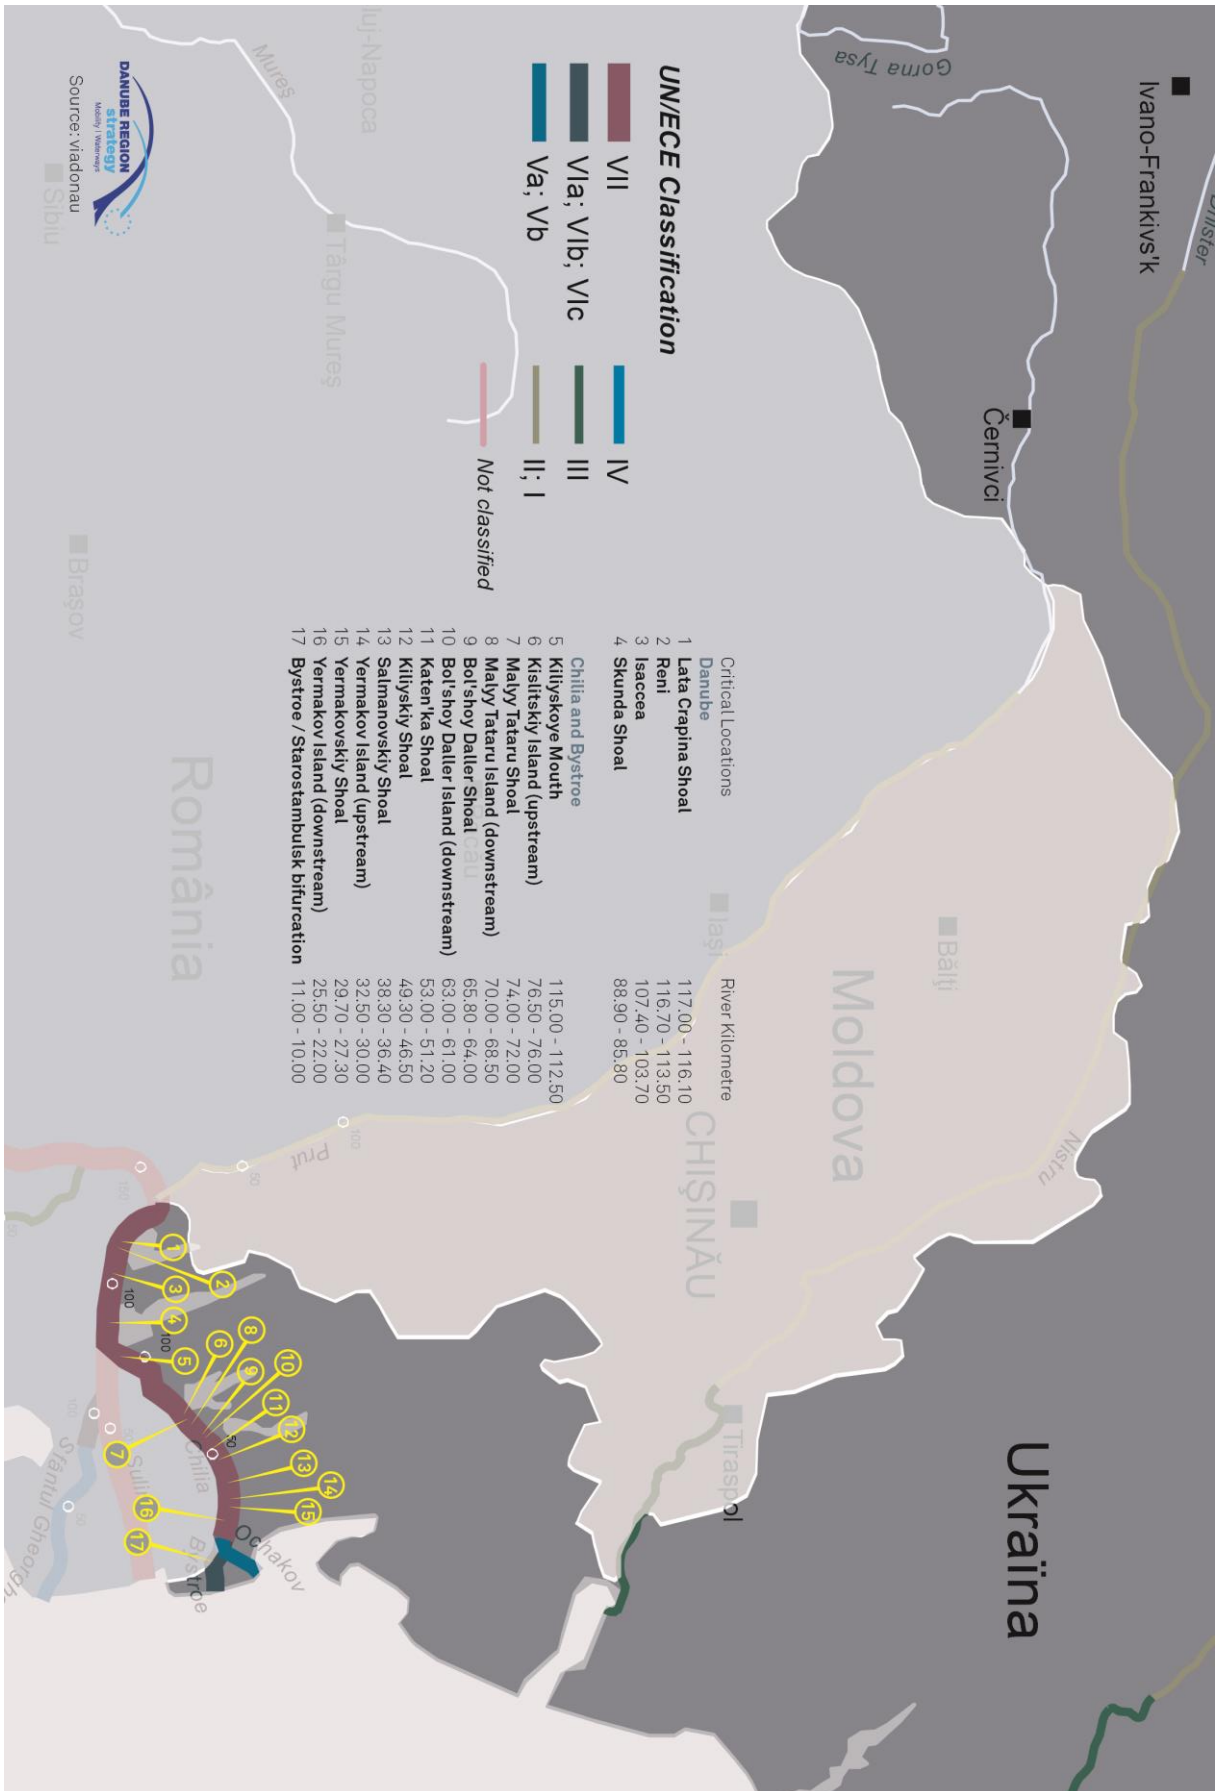
Ukraine: Overview of Critical Locations

Location / Length (km)			right bank / left bank	Name of sector / location
River-km (from / to)	Length			
115.00	112.50	2.50	RO / UA	Mouth Kilijske
76.50	76.00	0.50	RO / UA	Kislitskiy Island (upstream)
74.00	72.00	2.00	UA / UA	Malyy Tataru Shoal
70.00	68.50	1.50	UA / UA	Malyy Tataru Island (downstream)
65.80	64.00	1.80	UA / UA	Bol'shoy Daller Shoal
63.00	61.00	2.00	UA / UA	Bol'shoy Daller Island (downstream)
53.00	51.20	1.80	RO / UA	Katen'ka Shoal
49.30	46.50	2.80	RO / UA	Kilijskiy Shoal
38.30	36.40	1.90	RO / UA	Salmanovskiyo Shoal
32.50	30.00	2.50	RO / UA	Yermakov Island (upstream)
29.70	27.30	2.40	RO / UA	Yermakovskiyo Shoal
25.50	22.00	3.50	RO / UA	Yermakov Island (downstream)
11.00	10.00	1.00	RO / UA	Bystroe / Starostambulsk bifurcation
